STRIPPER FOIL DEVELOPMENTS AT NSCL/MSU*

Felix Marti[#], Scott Hitchcock, Peter Miller, Jeffry W. Stetson, John Yurkon,
NSCL/MSU, East Lansing, MI 48824, U.S.A.

Abstract

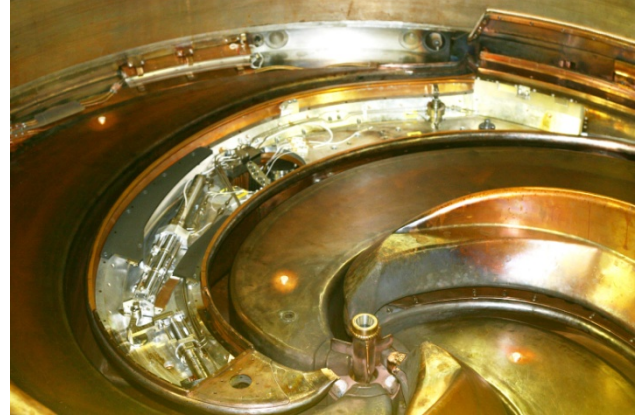
Figure 2 K1200 cyclotron. The upper half of the dee has been removed, as well as the RF shield that covers the stripper mechanism. The platter with the chain that drags the stripper foil holders has also been removed. The water cylinders used to drive the platter and locate the platter in the correct position are shown.

The stripper is located inside one of the dees in the

K1200 cyclotron, Figure 2. This aggressive environment (in vacuum, in a 5 T magnetic field and inside the high voltage accelerating structure) makes it difficult to install any diagnostics to observe the stripper foil.
